## **TRADITIONAL RESERVE STUDY**

### **Coral Lake Tower Association**

**Project Number 2420684**

November 25, 2024

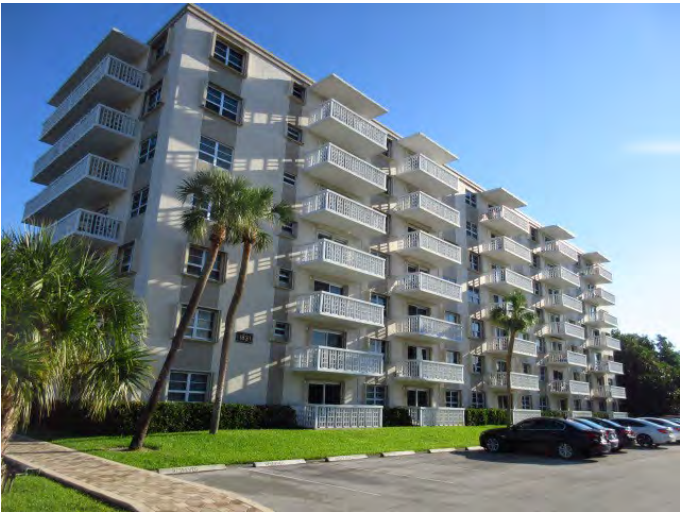
**PHOTO 2**

GENERAL VIEW OF PROPERTY

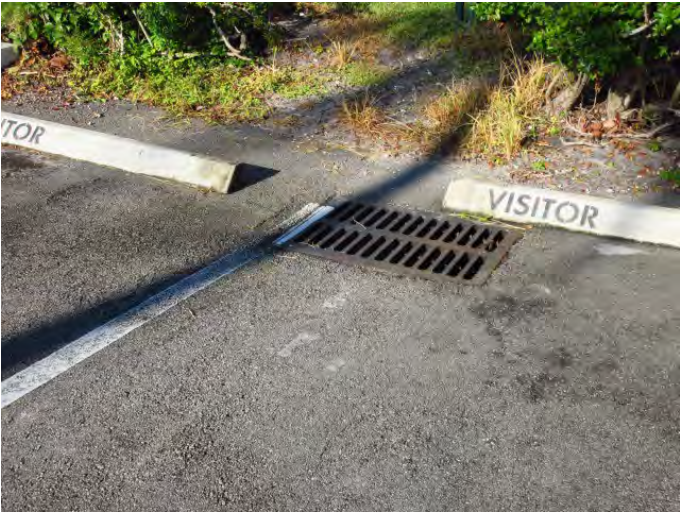
**PHOTO 3**

GENERAL VIEW OF STORM WATER INLET

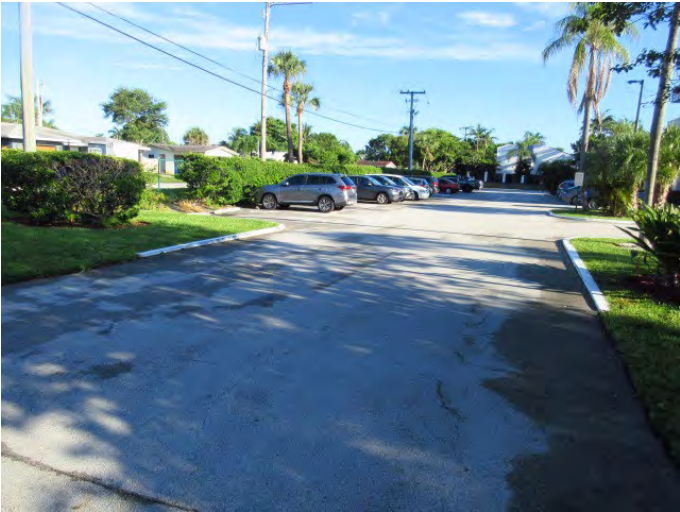
**PHOTO 4**

<b>Parking/Paving</b>	<p>The interior drives and parking areas are paved with asphalt.</p> <p><b>The parking and driveway areas were noted to be in good condition. Periodic asphalt pavement crack-sealing, sealcoating, and striping, as well as pavers sealing and resetting are recommended during the evaluation period. Funds have been allocated in the Replacement Reserves Cost Estimate Tables.</b></p> <p><b>In addition, based on the expected useful life (EUL) of 25 years, funds for asphalt pavement resurfacing have been allocated in the Replacement Reserves Cost Estimate Tables.</b></p>
<b>Site Lighting</b>	<p>Site lighting is provided by building-mounted and pole-mounted fixtures.</p> <p><b>We do not anticipate the need for significant replacement of the light fixtures within the evaluation period of this assessment. Funds for upkeep and upgrades of the light fixtures are considered part of routine maintenance.</b></p>

VIEW OF PARKING AND PAVEMENT

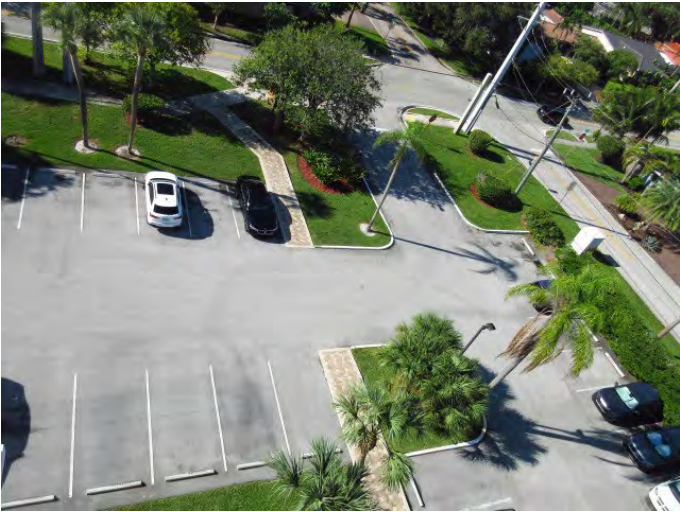
**PHOTO 5**

GENERAL VIEW OF PARKING AND PAVEMENT

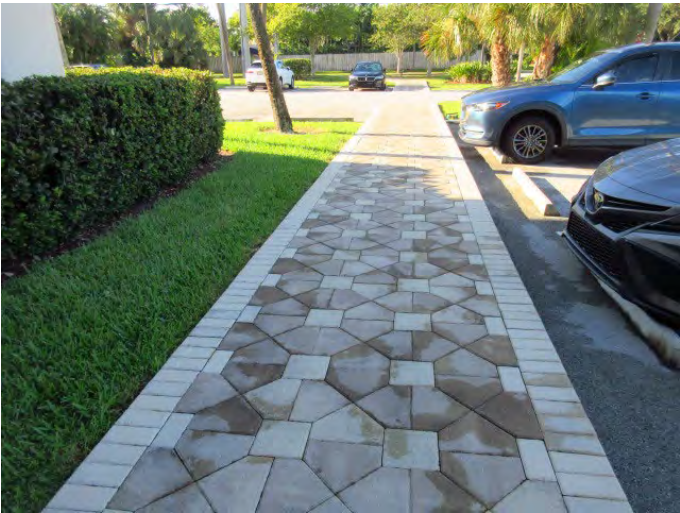
**PHOTO 6**

VIEW OF SIDEWALK

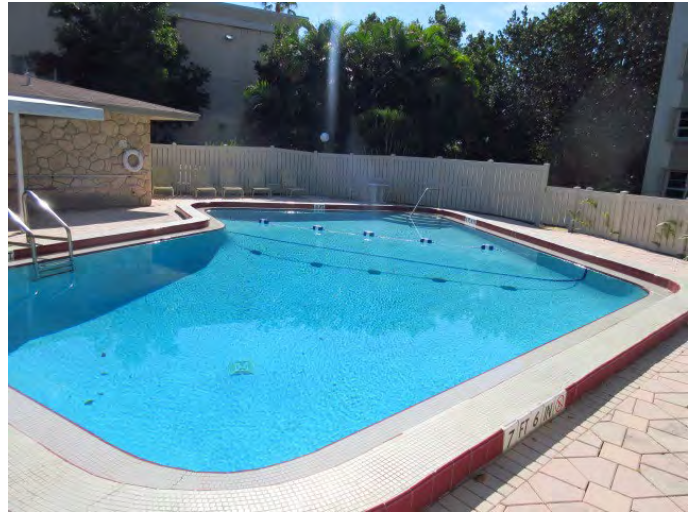
**PHOTO 7**

<b>Swimming Pool</b>	<p>The Property has an in-ground outdoor swimming pool. The swimming pool is constructed of concrete, with concrete coping, and concrete deck surrounding the pool.</p> <p><b>Based on the EUL of 10 years, resurfacing should be anticipated during the evaluation period. Funds have been allocated in the Replacement Reserves Cost Estimate Tables.</b></p>
<b>Pool Equipment</b>	<p>The swimming pool equipment consists of a heater, water filter and circulating pump.</p> <p><b>The swimming pool equipment was noted to be in good operating condition. Based on the EUL of 10 years, funds for replacement have been allocated in the Replacement Reserves Cost Estimate Tables.</b></p>

GENERAL VIEW OF SWIMMING POOL

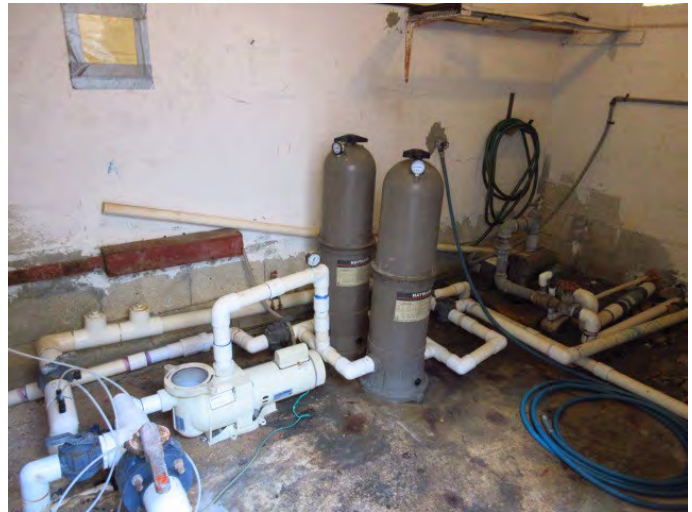
**PHOTO 8**

GENERAL VIEW OF SWIMMING POOL EQUIPMENT

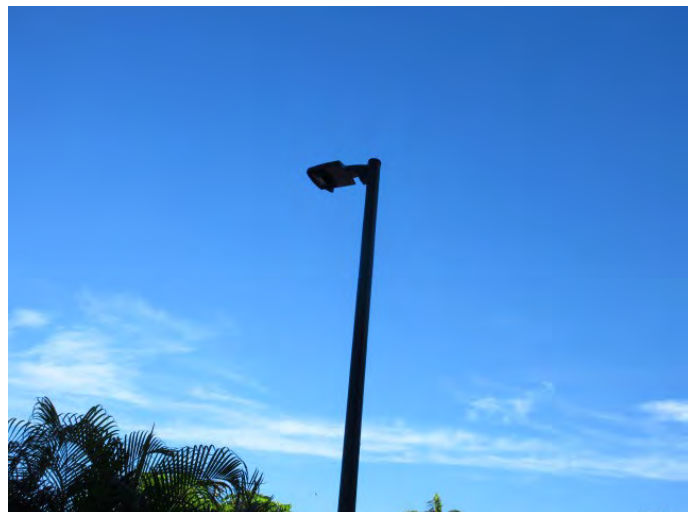
**PHOTO 9**

VIEW OF SITE LIGHTING

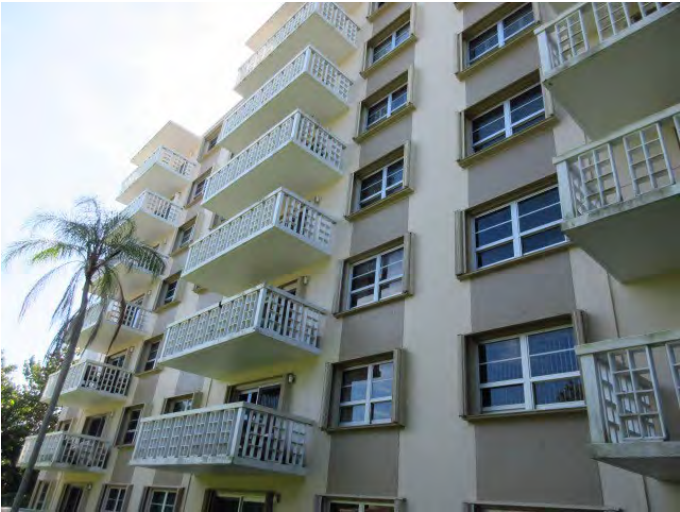
**PHOTO 10**

GENERAL VIEW OF BUILDING EXTERIOR FINISHES

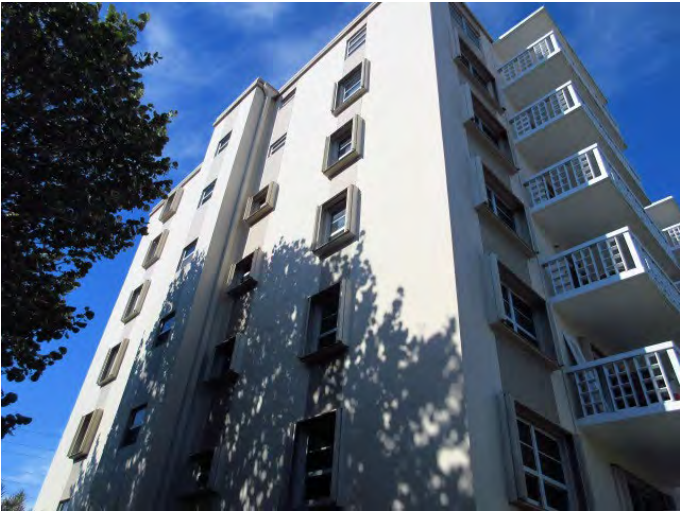
**PHOTO 11**

GENERAL VIEW OF BUILDING EXTERIOR FINISHES

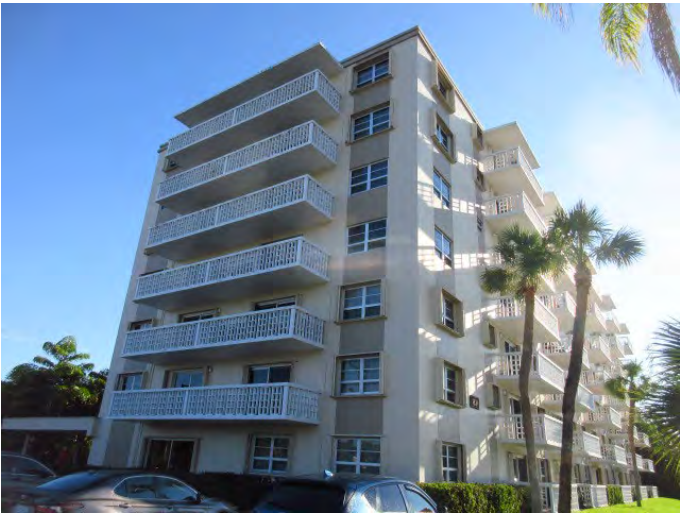
**PHOTO 12**

VIEW OF BUILDING EXTERIOR FINISHES

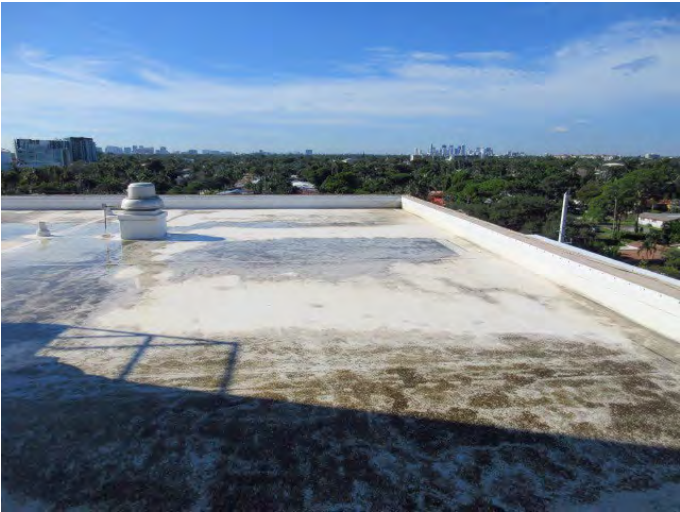
**PHOTO 13**

<b>Roofs</b>	<p>The low slope (flat) roofing system is covered with TPO single-ply membrane.</p> <p><b>Based on the EUL of 20 years for TPO roofing systems, funds for replacement have been allocated in the Replacement Reserves Cost Estimate Tables.</b></p> <p><b>Please note that the extent of the roof evaluation did not include any sampling and/or testing involved therefore comments made regarding the condition of the roof are limited to visual observation as well as historical information provided by site contact and/or Property respondent. Should a more comprehensive investigation be required, the services of a certified roofing consultant should be considered.</b></p>

GENERAL VIEW OF ROOF COVERING

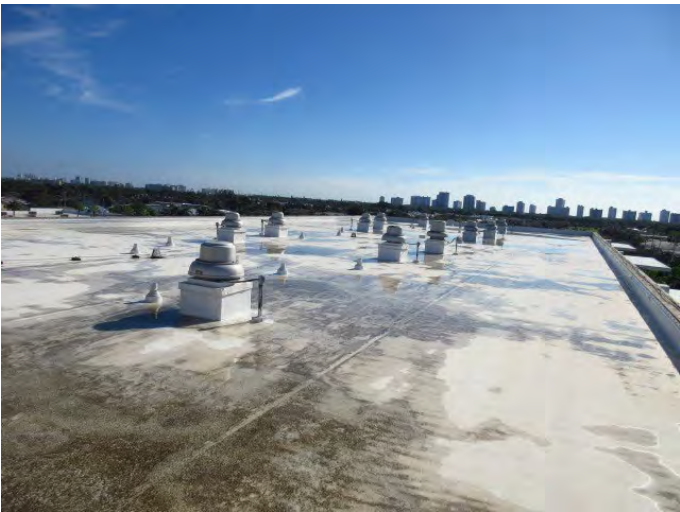
**PHOTO 14**

GENERAL VIEW OF ROOF COVERING

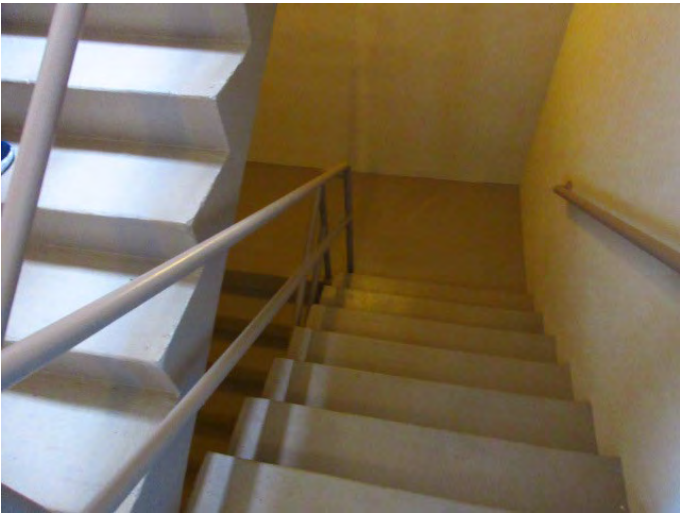
**PHOTO 15**

VIEW OF INTERIOR STAIRS

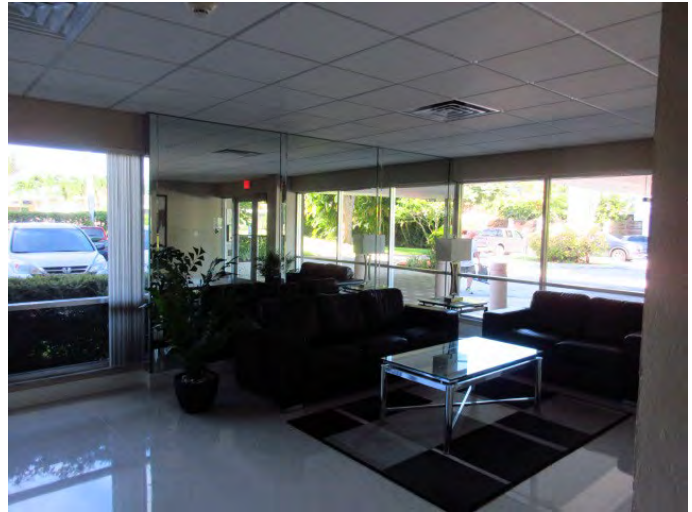
**PHOTO 16**

VIEW OF MAIN ENTRANCE LOBBY

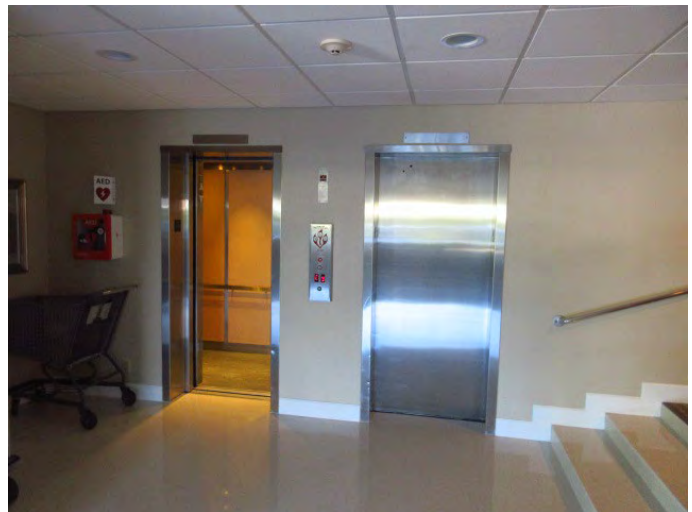
**PHOTO 18**

VIEW OF ELEVATOR LOBBY

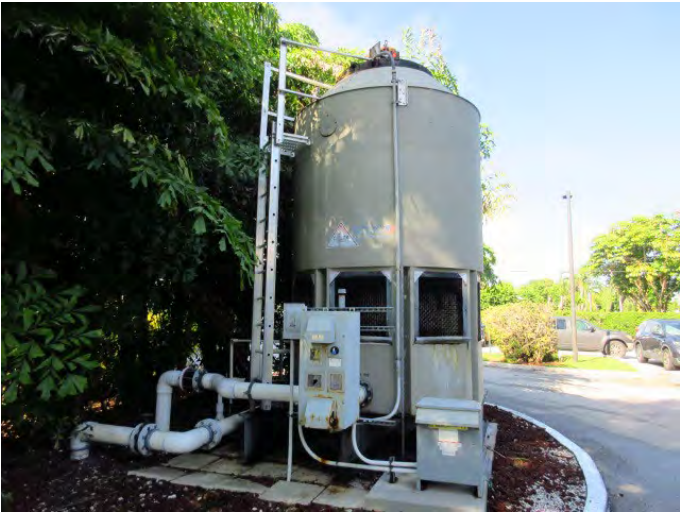
**PHOTO 19**

Item	Description/Observations/Comments
HVAC	<p>Cooling is provided via a central water-cooled cooling tower approximately 175-ton in cooling capacity, located at grade level, supplying multiple air-handling units throughout the building.</p> <p><b>Cooling towers have a typical EUL of 25 years. Funds for replacement have been allocated in the Replacement Reserves Cost Estimate Tables.</b></p>
Plumbing Systems	<p>According to available information and observations, supply piping is noted to be copper. The waste piping is presumed to include polyvinyl chloride (PVC).</p> <p><b>The plumbing systems were reported to be in good condition.</b></p> <p><b>Plumbing components have EULs between 15 and 45 years. As such, an annual budget for component upgrades and replacements is recommended during the evaluation period. Funds have been allocated in the Replacement Reserves Cost Estimate Tables.</b></p>

GENERAL VIEW OF COOLING TOWER

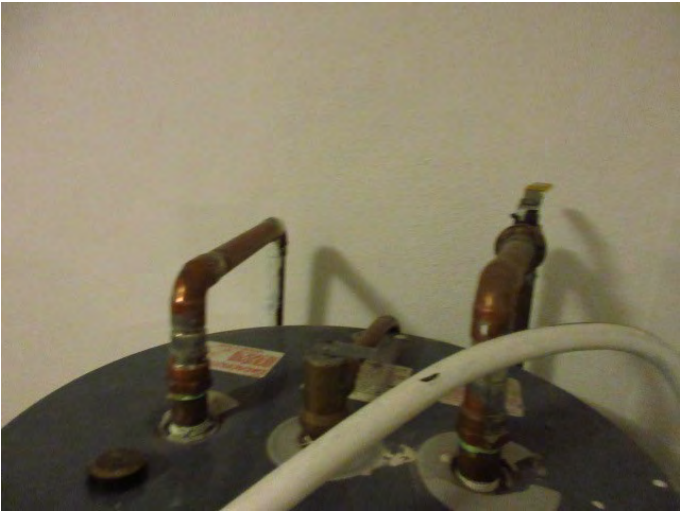
**PHOTO 20**

GENERAL VIEW OF PLUMBING SYSTEM

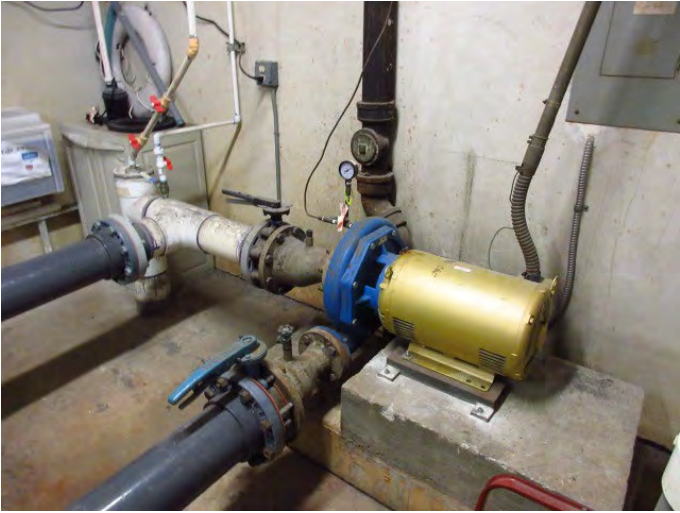
**PHOTO 21**

VIEW OF PLUMBING SYSTEM

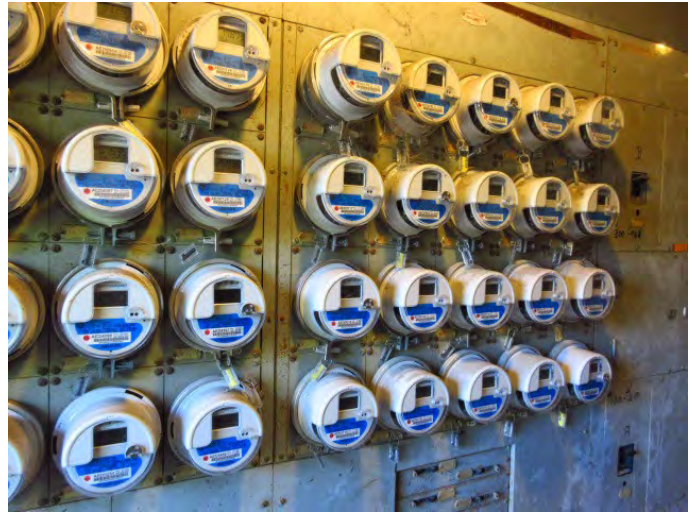
**PHOTO 22**

GENERAL VIEW OF ELECTRICAL SYSTEM

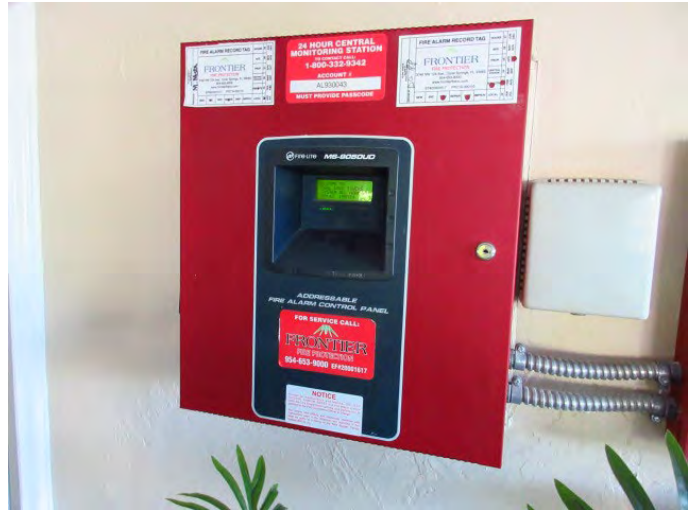
**PHOTO 23**

GENERAL VIEW OF CENTRAL ALARM PANEL

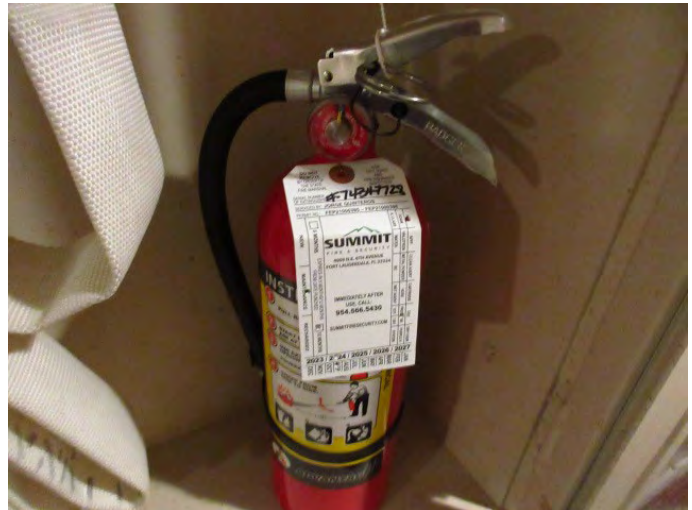
**PHOTO 24**

Item	Description/Observations/Comments
<b>Fire Protection</b>	<p>The building is equipped fire extinguishers, and as central alarm panel.</p> <p><b>The fire system was noted to be in good operating condition. Funds for component replacement have been allocated in the Replacement Reserves Cost Estimate Tables.</b></p> <p>Fire protection and life safety systems within the units are reported to be the responsibility of the respective unit owner to maintain and replace.</p>

VIEW OF TYPICAL FIRE EXTINGUISHER
