**STRUCTURAL INTEGRITY RESERVE STUDY**

***The Coral Lake Tower Association, Inc.***  
*1831 NE 38<sup>th</sup> Street, Oakland Park, FL 33308*

*Prepared by: Gregorio Batista, PE, CGC, and Kristian Cano*  
*Inspected on: August 7, 2024*  
*Prepared on: August 13, 2024*

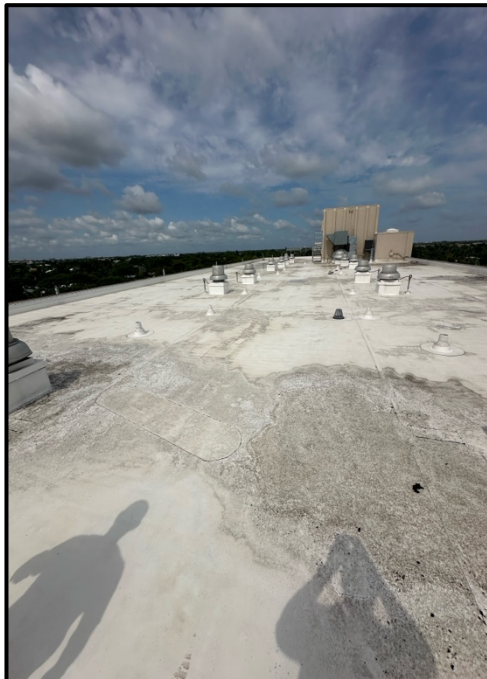
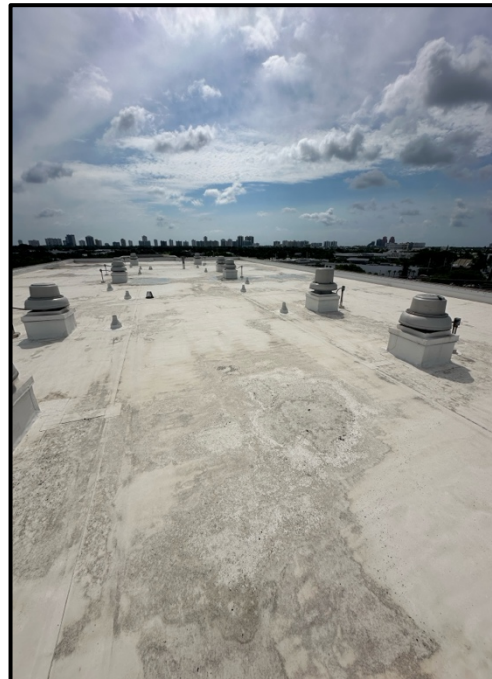
**Condition:** The roof is in satisfactory conditions.

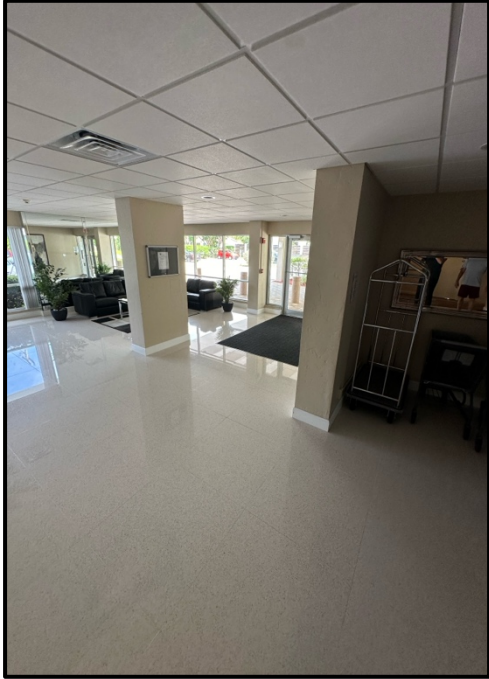
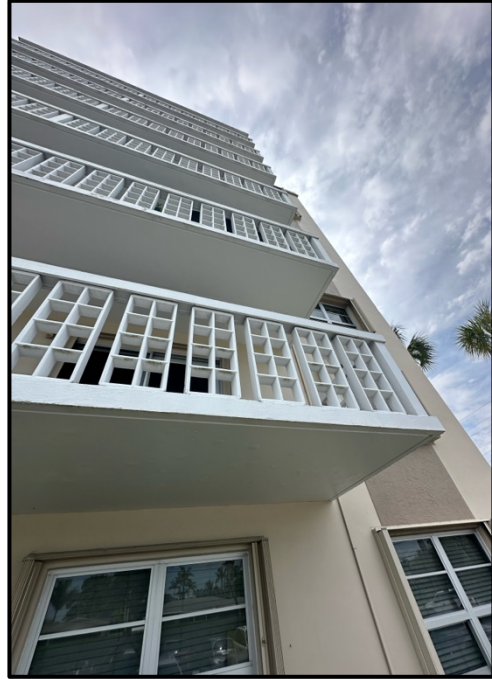
**Condition:** The concrete framing and floor systems is in satisfactory condition.

**Remaining Lifespan:** Although concrete is a very durable material, due to the location's proximity to the coast, spalling due to rebar corrosion usually manifests before the concrete naturally deteriorates. It is important to note that it is rarely possible to visually inspect and examine all the concealed construction, nor should be generally necessary. Our conclusions are based upon our experience and conditions examined in the exterior typical structural members of the building. Refer to the table presented at the end of this report.

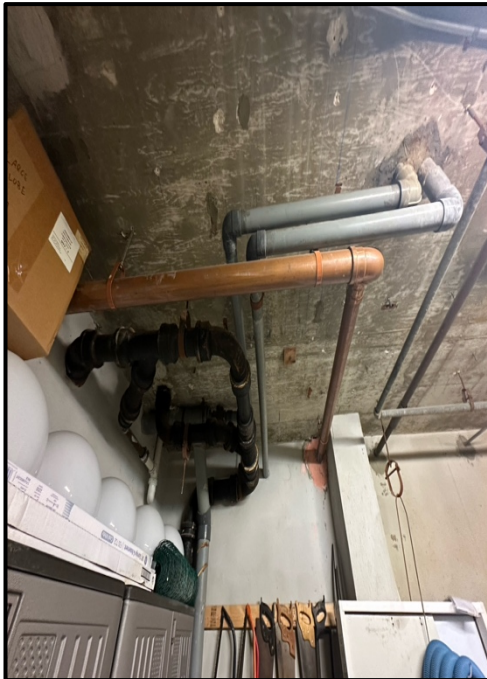
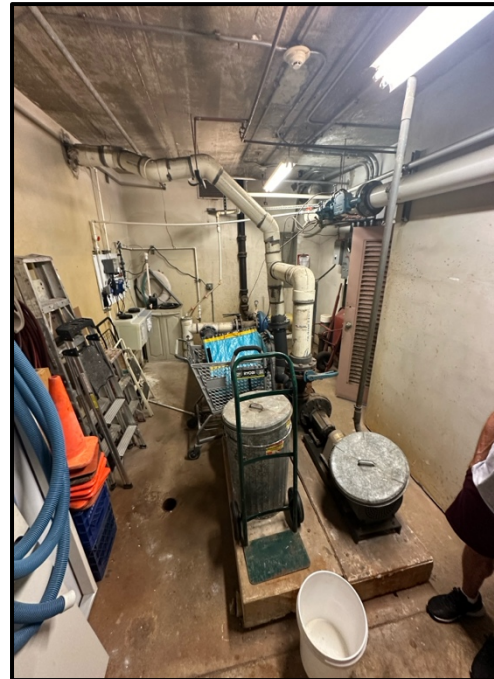
**Condition:** The plumbing system in fair condition. It is important to note that it is rarely possible to visually inspect and examine all the concealed construction, nor should be generally necessary. Our conclusions are based upon our experience and deficiencies found in the visible and readily accessible areas.

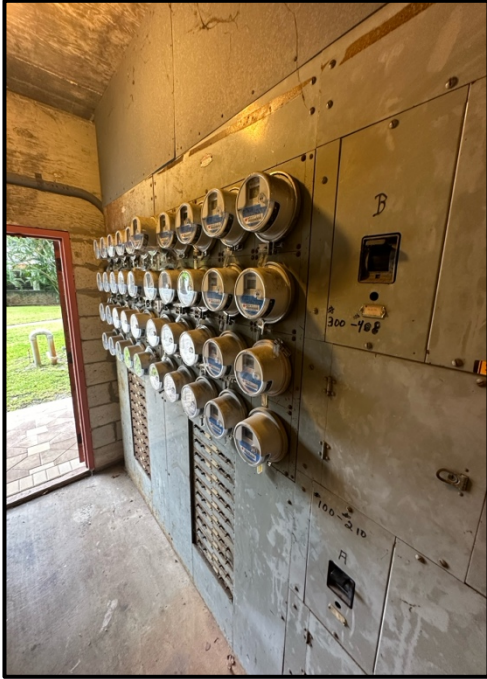
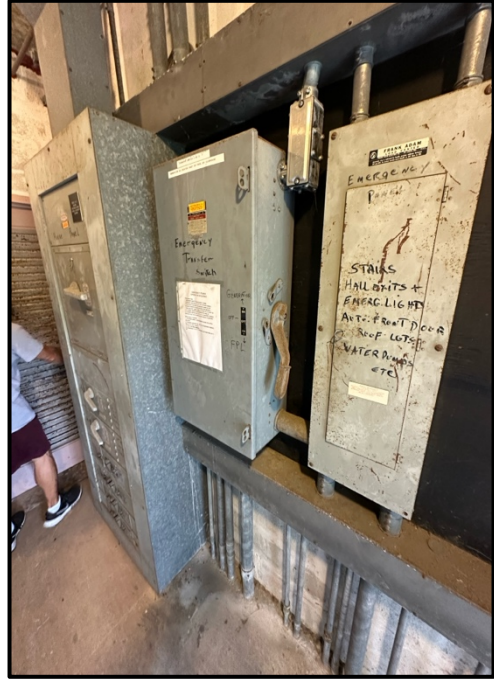
**Condition:** The electrical system(s) is in fair condition.

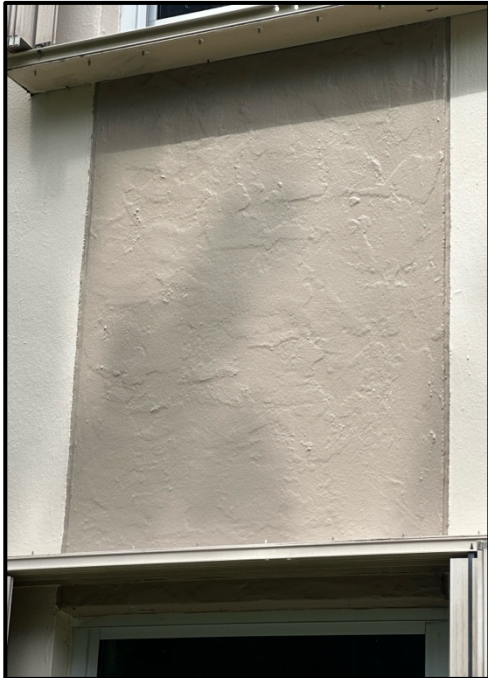
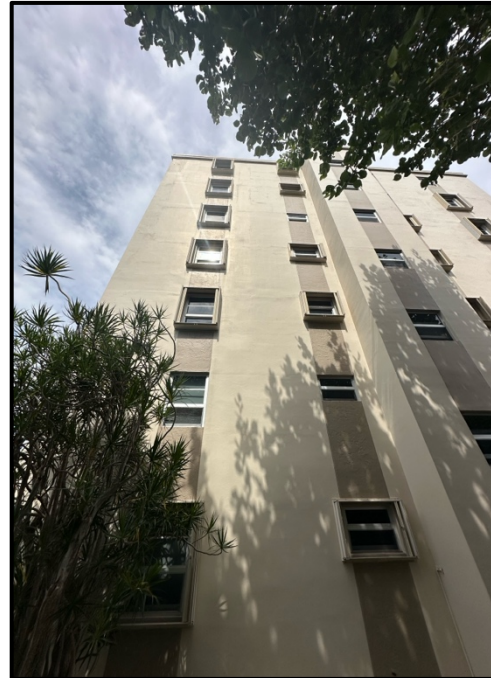
**Condition:** The exterior stucco is in good condition. It is important to note that our conclusions are based upon our experience and deficiencies found in the visible and readily accessible areas.

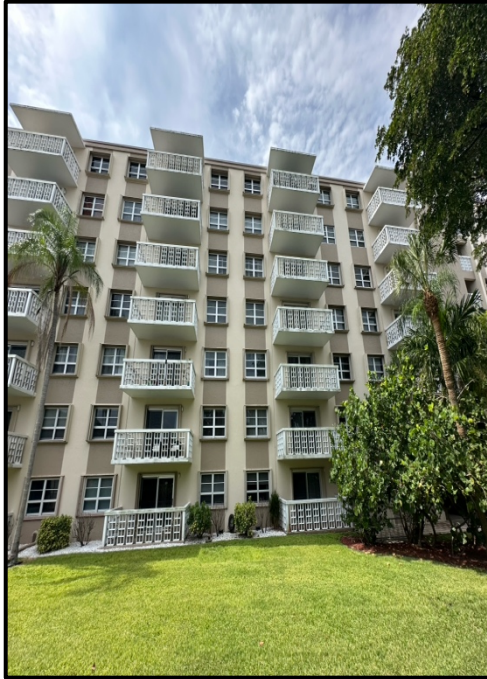
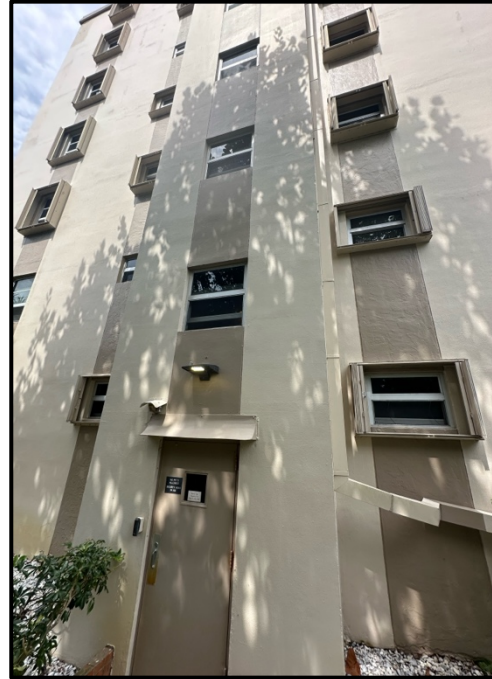
**Condition:** The surfaces appear to be in satisfactory condition.

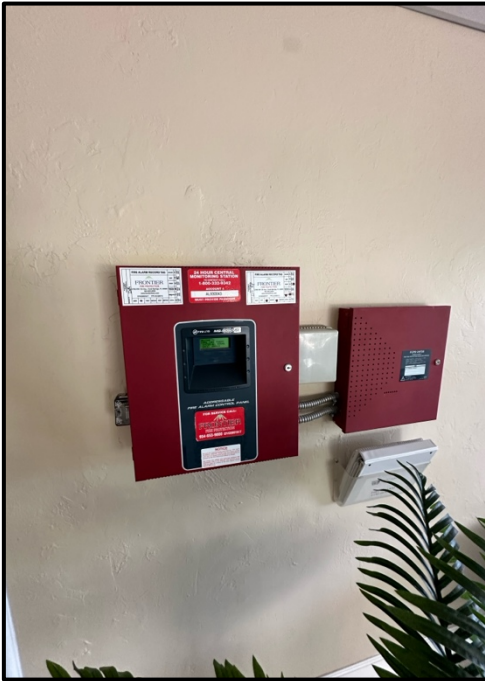
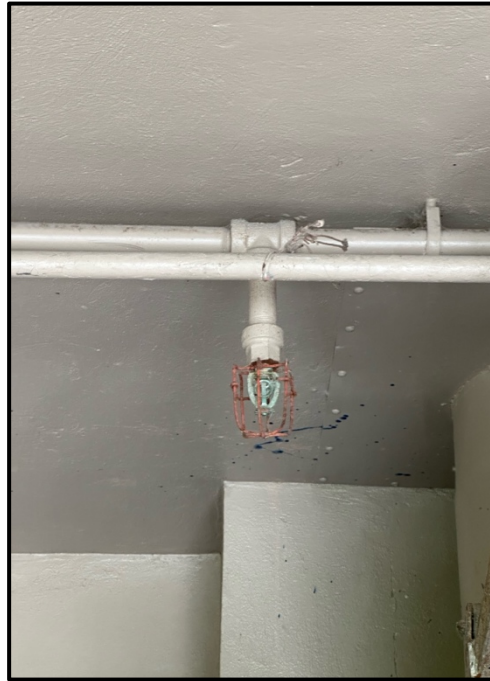
**Condition:** The fire protection systems appear to be in fair condition.

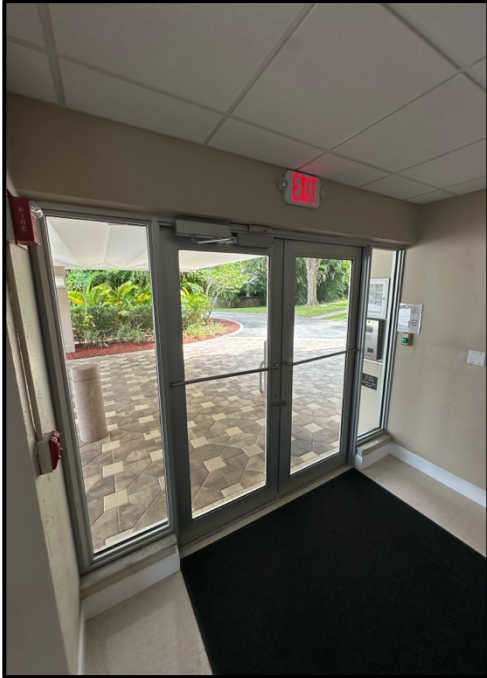
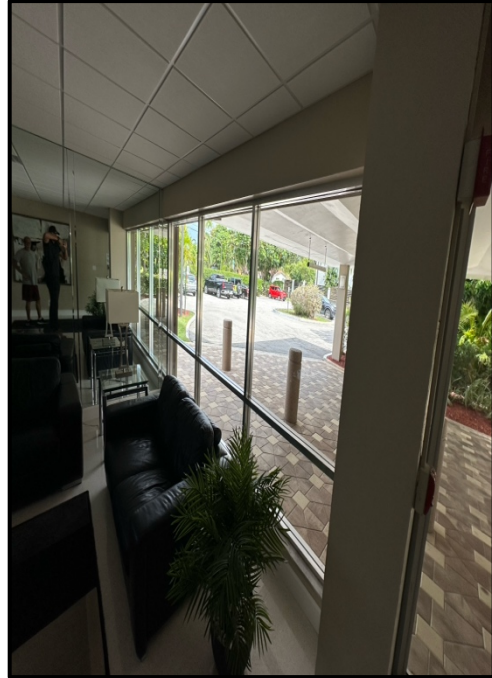
**Condition:** The common area windows and doors appear to be in good condition. The association is only responsible for the common areas. The units' windows and doors are the unit owner's responsibility.
